Contract #: 04-0120F4Cty: SF/ALA Rte: 80 PM: 13.2/13.9File #: 69.28**WELDING INSPECTION REPORT****Resident Engineer:**Pursell, Gary**Address:** 333 Burma Road**City:** Oakland, CA 94607**Report No:** WIR-002452**Date Inspected:** 02-May-2008**Project Name:** SAS Superstructure**OSM Arrival Time:** 2300**Prime Contractor:** American Bridge/Fluor Enterprises, a JV**OSM Departure Time:** 1130**Contractor:** Zhenhua Port Machinery Company, Ltd (ZPMC), Changxing Island **Location:** Shanghai, China**CWI Name:** Xu Le Feng**CWI Present:** Yes No**Inspected CWI report:** Yes No N/A**Rod Oven in Use:** Yes No N/A**Electrode to specification:** Yes No N/A**Weld Procedures Followed:** Yes No N/A**Qualified Welders:** Yes No N/A**Verified Joint Fit-up:** Yes No N/A**Approved Drawings:** Yes No N/A**Approved WPS:** Yes No N/A**Delayed / Cancelled:** Yes No N/A**Bridge No:** 34-0006**Component:** OBG & Tower**Summary of Items Observed:**

WELDING INSPECTION REPORT

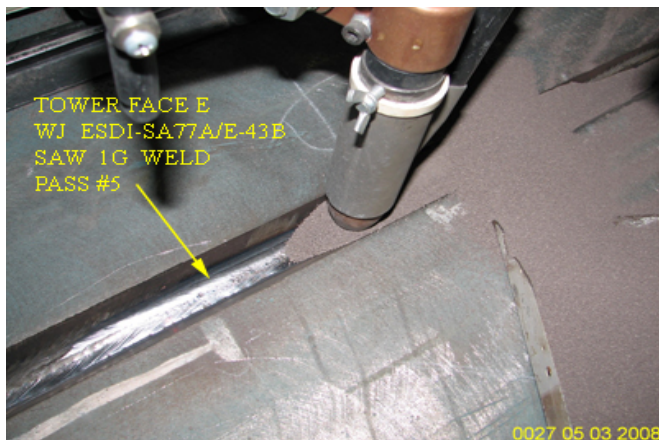
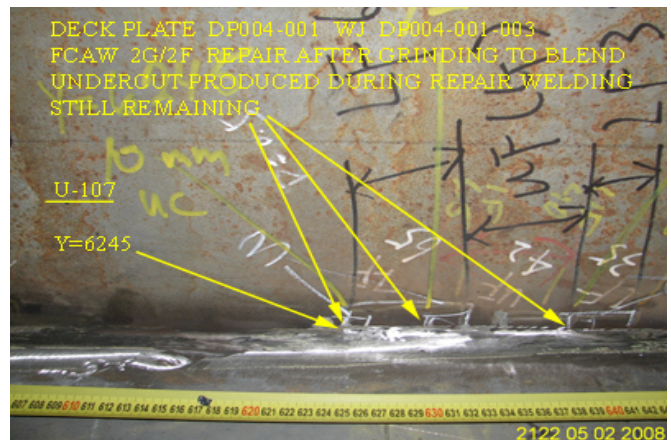
The QA Inspector randomly observed ZPMC welder Shen Mei ID Number 041716, utilizing the Submerged Arc Welding (SAW) Process in the 1G Position (Flat Groove) with ZPMC Weld Procedure Specification (WPS) WPS-B-P-2221-B-U3c-S-1, to weld the root pass in Weld Joint (WJ) ESD1-SA77A/E-43B on Tower Skin Plate E Sub-Assembly SA77(E). The QA Inspector randomly observed ZPMC CWI Xu Le Feng monitoring weld parameters. The QA Inspector also randomly monitored weld parameters and recorded them as follows: 520 amps, 29.1 volts with a travel speed of 455 millimeters (mm) per minute. The weld parameters appeared to comply with contract requirements. The attached photograph provides additional detail.

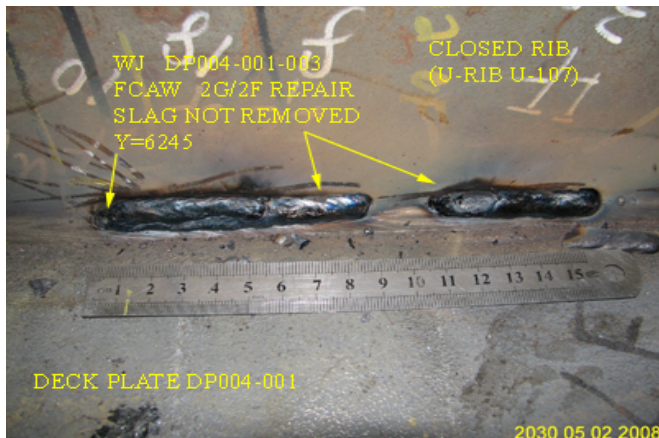
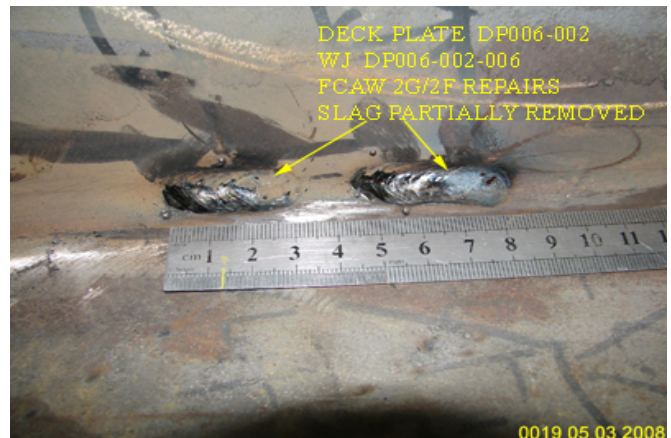
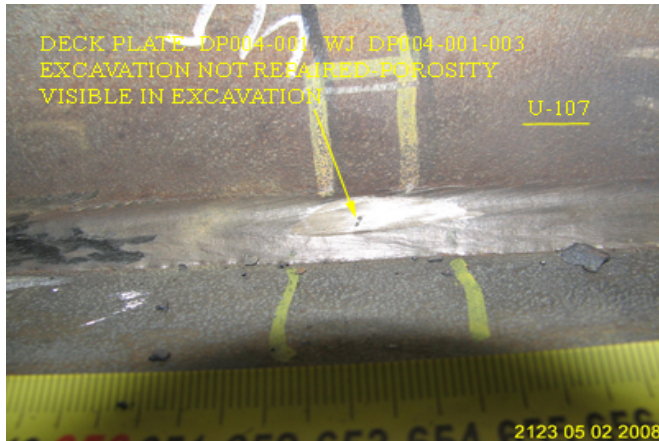
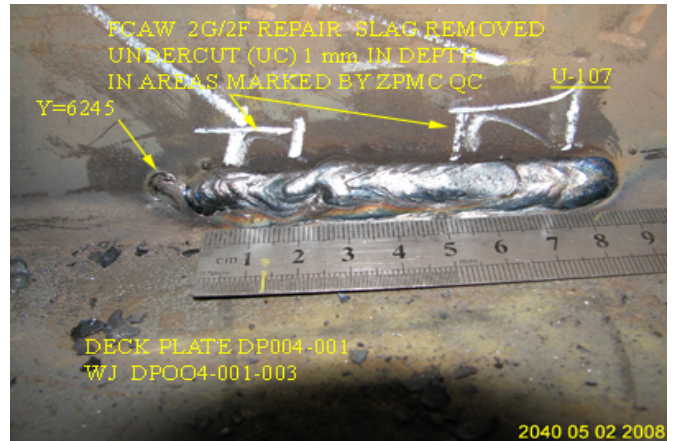
The QA Inspector randomly observed ZPMC welding personnel utilizing 4-1/2 inch grinders to blend and feather welds after weld repair and to remove overlap and reduce oversized welds on Deck Plate DP004-001 WJ Numbers DP004-001-001 through 010, U-Ribs U-109, U-107 and U-108 respectively. The QA Inspector randomly observed that several repaired areas on WJ DP004-001-003 beginning at location Y=6245, had Undercut (UC) to a depth of 1 mm below flush at the top of the weld in the base metal of U-rib U-109, after the weld repair. The area at location Y=6245 had 10 mm of UC, Y=6295 25 mm of UC, Y=6380 40 mm of UC, Y=6720 40 mm of UC and Y=6520; which had been excavated for a length of 30 mm but not repaired. The QA Inspector also randomly observed 10 mm of UC in a weld repair at Y=6010 in WJ DP004-001-006. These areas had not been blended at this time. The QA Inspector informed American Bridge/Fluor Enterprises QC Representative Ding Buohua, and Mr. Ding marked the areas of UC with white paint marker. The QA Inspector then randomly observed ZPMC helpers utilize the 4-1/2 inch angle grinders to blend the welds containing the UC, with the UC remaining after the grinding was completed. The attached photographs provide additional detail.

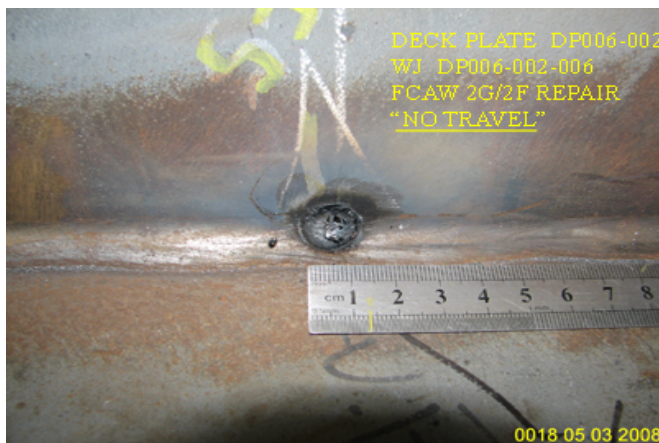
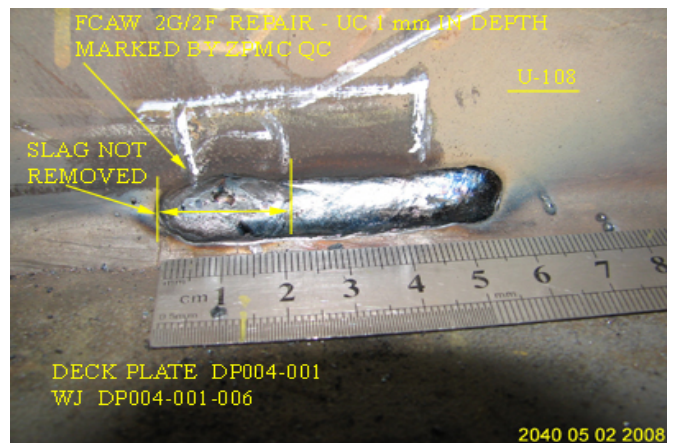
The QA Inspector randomly observed ZPMC welding personnel utilizing 4-1/2 inch grinders to blend and feather welds after weld repair and to remove overlap and reduce oversized welds on Deck Plate DP006-002 WJ Numbers DP004-001-001 through 008, U-Ribs U-167, U-101, U-169 and U-88 respectively. The attached photographs provide additional detail.
